# **The Evaluation of Historic Structures**

## Structural Engineers Association of Wisconsin

Timothy Crowe, RA, SE, PE  
April 21, 2017

## **Presentation Objectives**

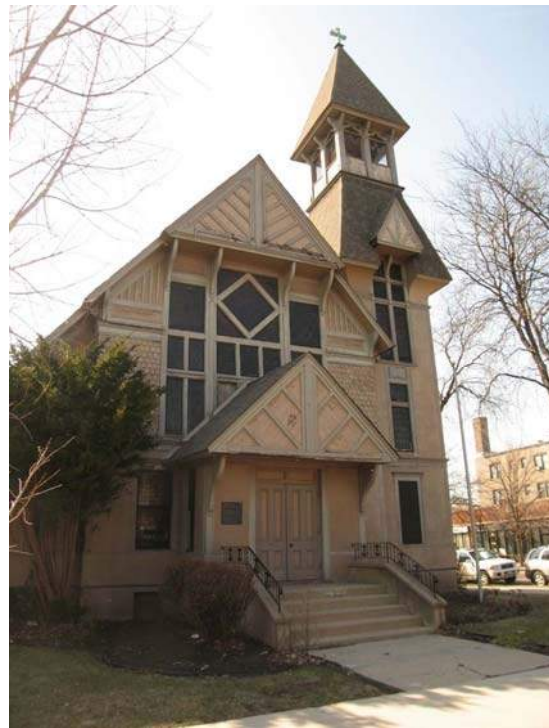
1883 Wood framed church, Code officials – administrative relief.

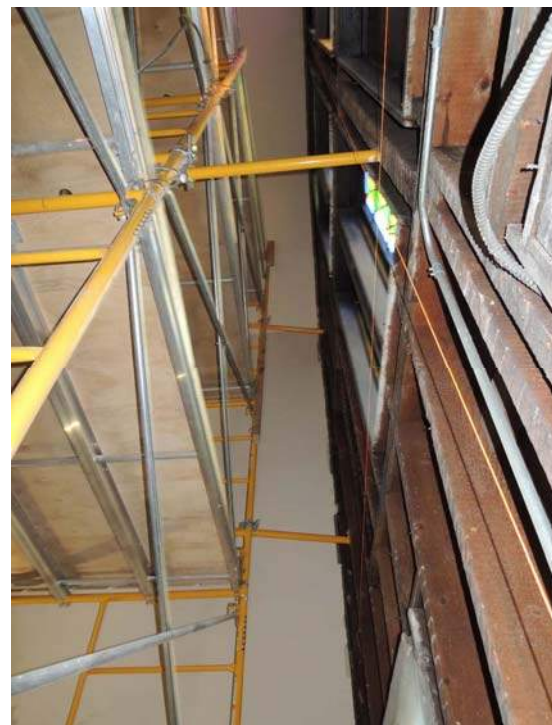
Bowed wall, with discontinuous studs.

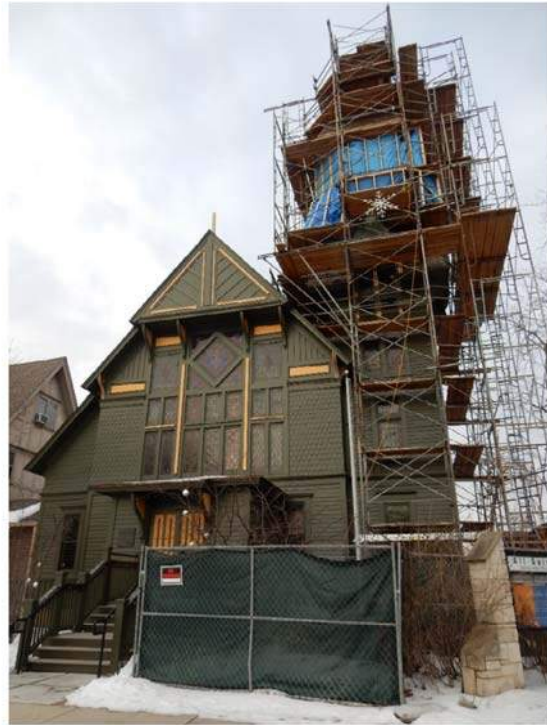
1884 Wood framed church, Code officials – administrative relief.

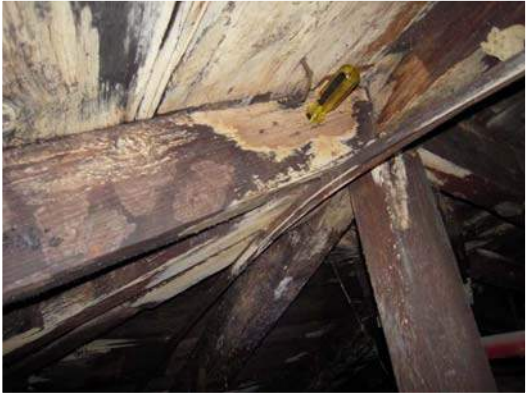
18 50s roof framing in Washington DC, Moisture effects, Longer term moisture infiltration, roof

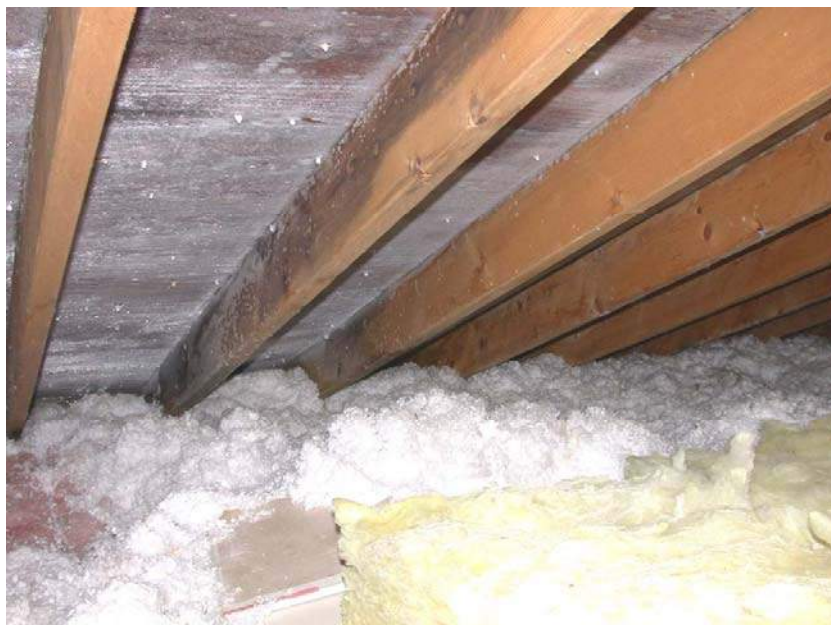
Moisture effects, Poor vapor barrier and air barrier into attic. Condensation and frost.

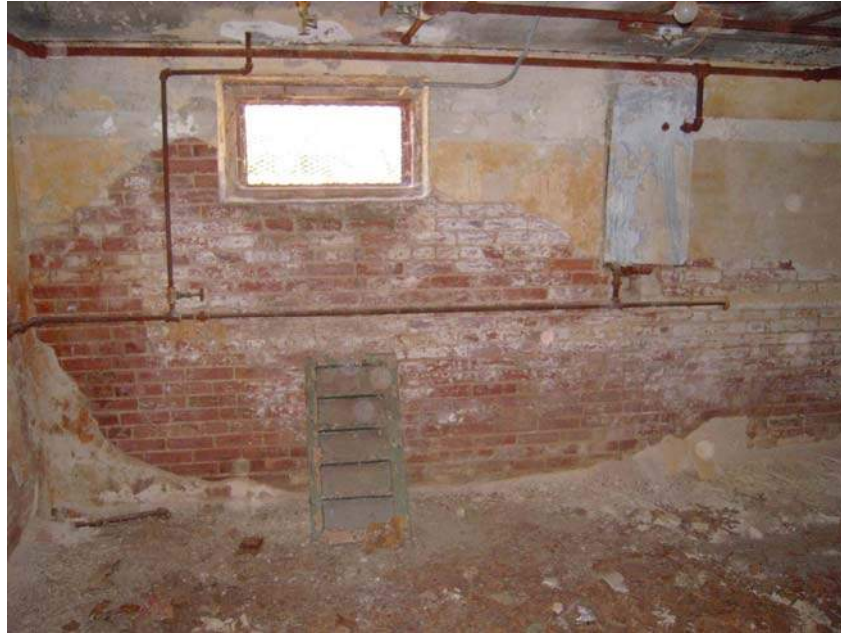
Moisture effects, rising damp, deterioration to foundations.

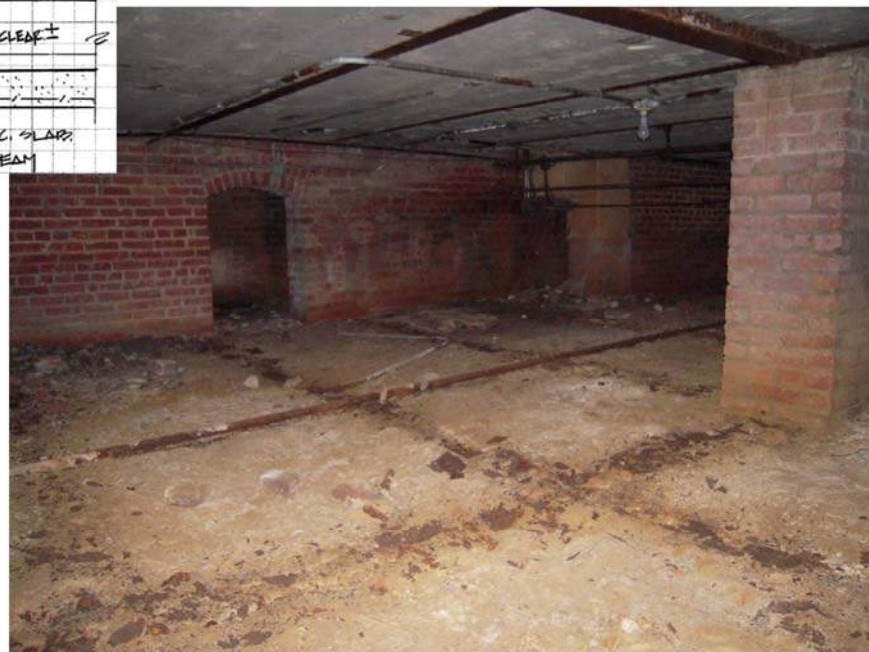
Moisture effects, Exposed steel in poorly vented crawlspace

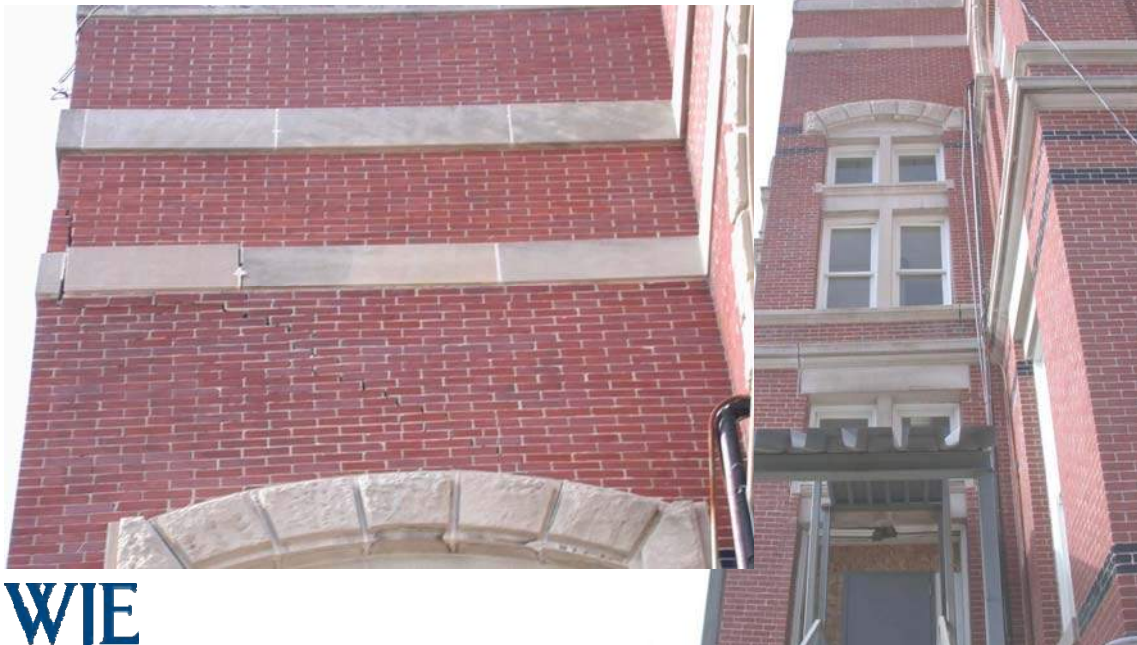
Cracks and displacement

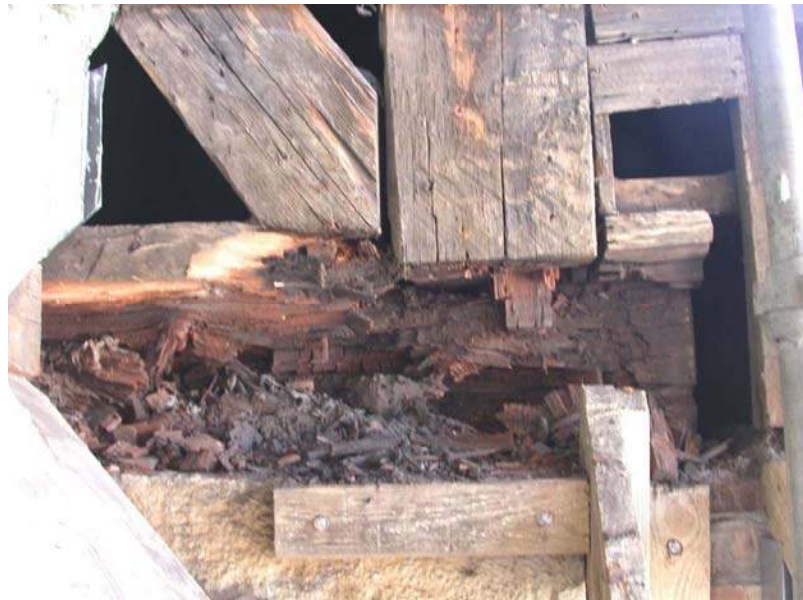
Decay and displacement of framing members in 1870s Bbell tower.

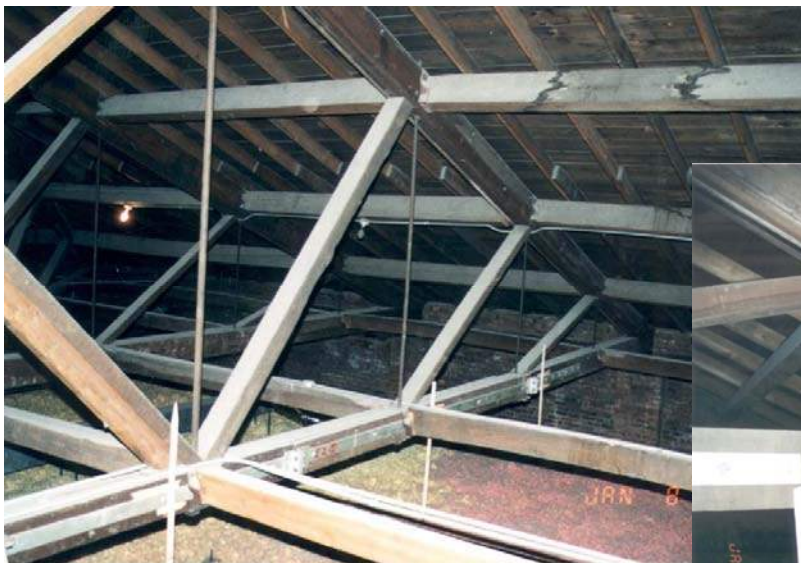
Past interventions: 1908 university building in Lincoln Nebraska

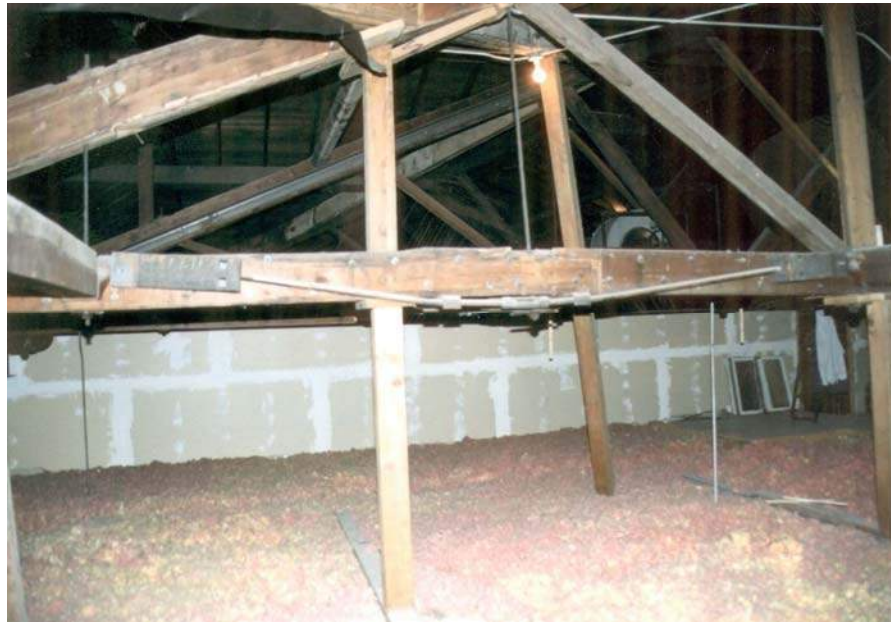
Past interventions: 1908 university building in Lincoln Nebraska

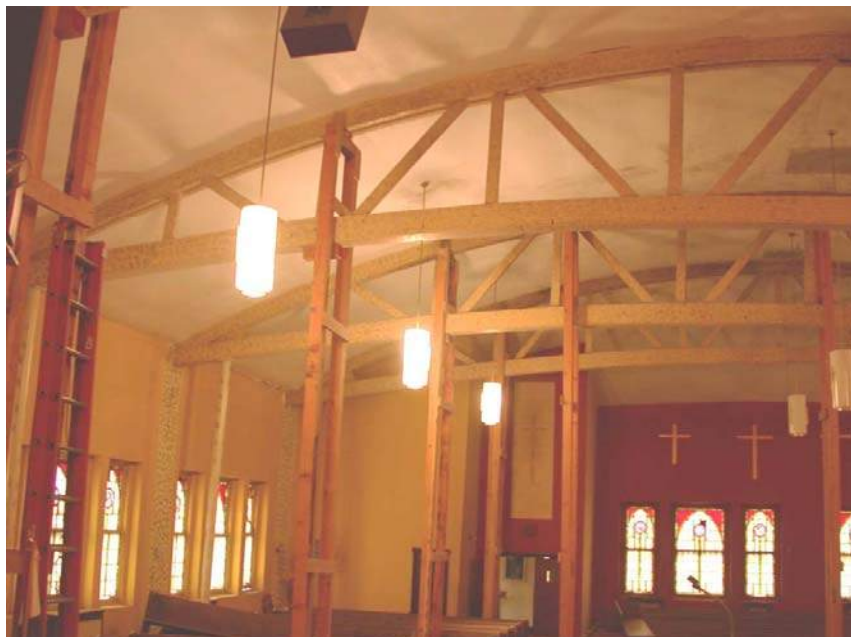
Past interventions: 1915 Church building

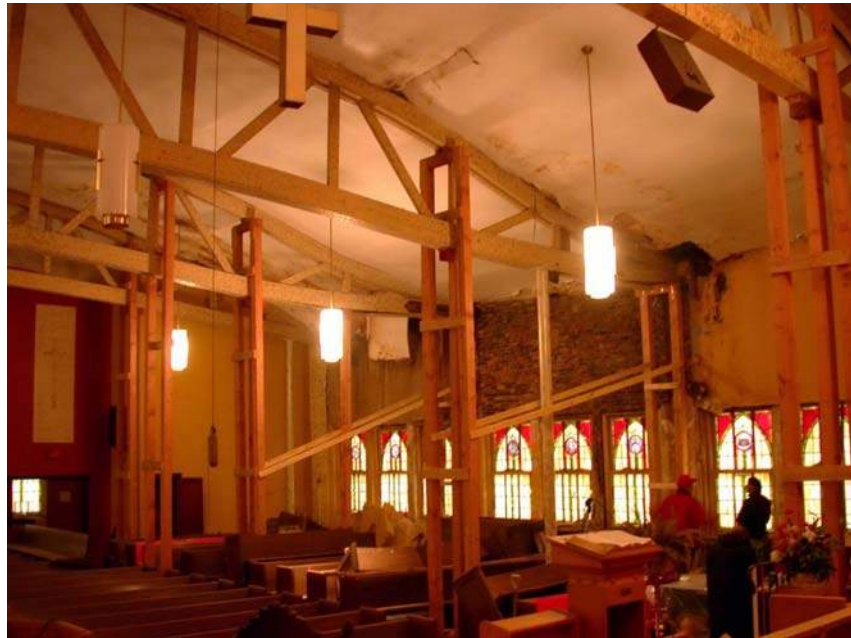
Past interventions: 1915 Church building

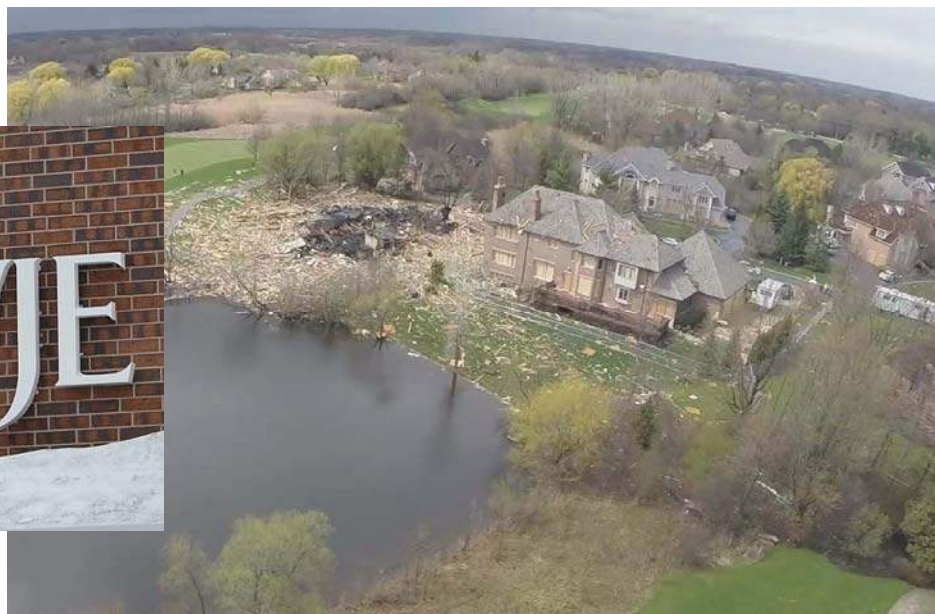
Use of Drones is now an option in certain situations.

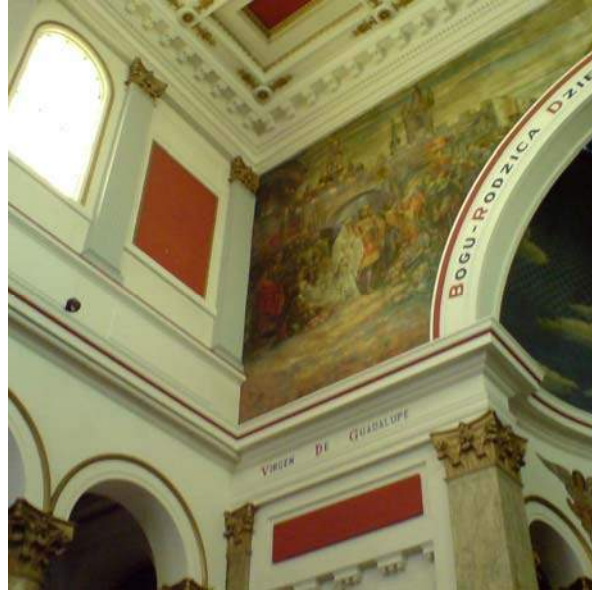
Infrared photography:

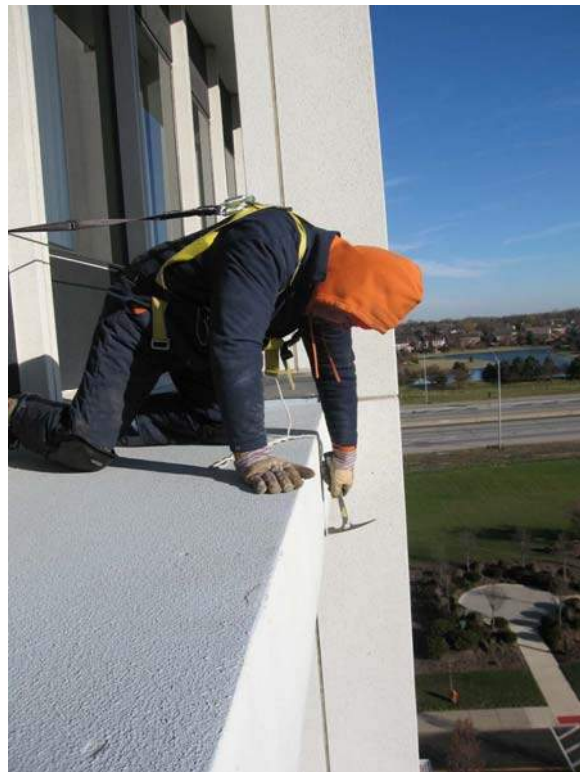
Simple hand tools,  
keep things low-tech.

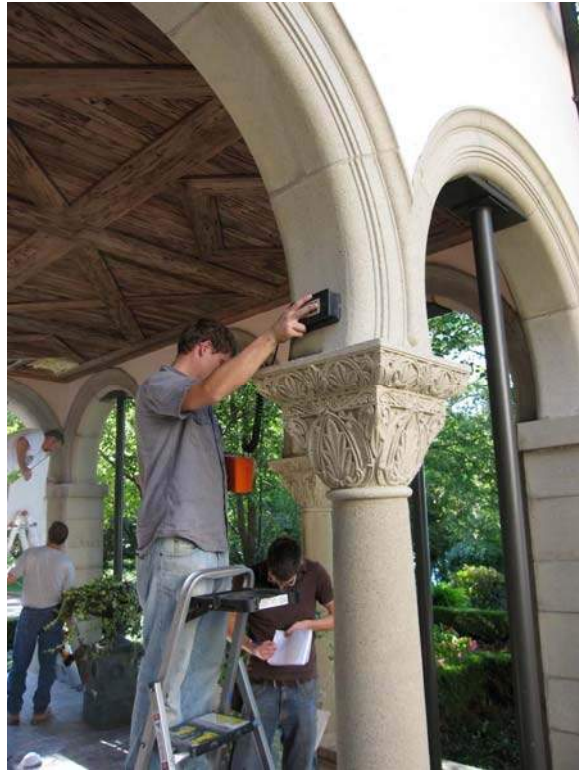
Ultrasonic testing devices such as GPR.

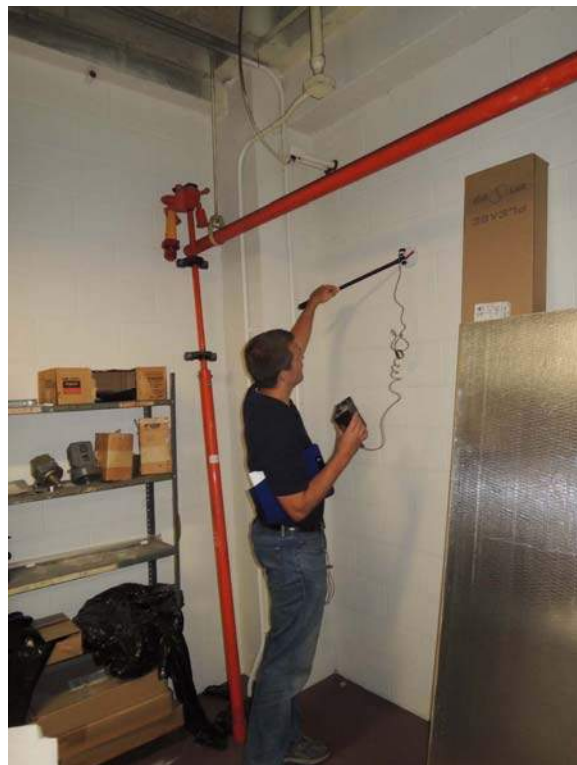
Ultrasonic testing devices such as metal detector .

Actually is useful for concrete, masonry, wood

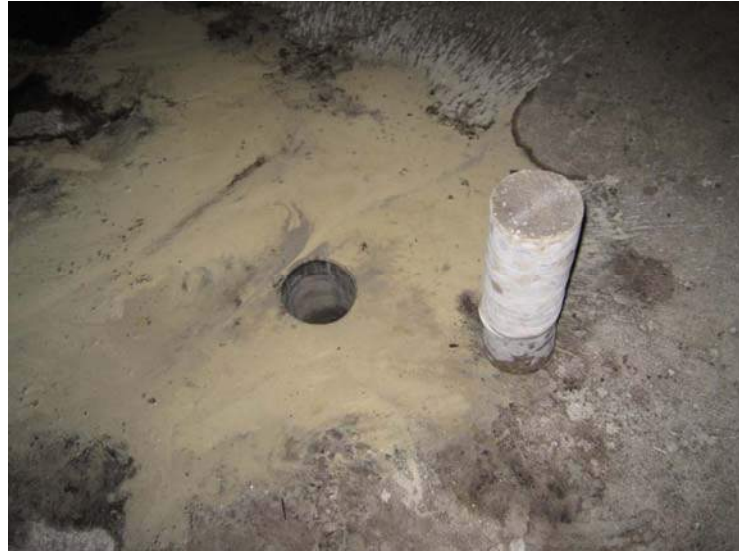
Coring of material  
for compressive  
strength testing  
and chemical  
analysis

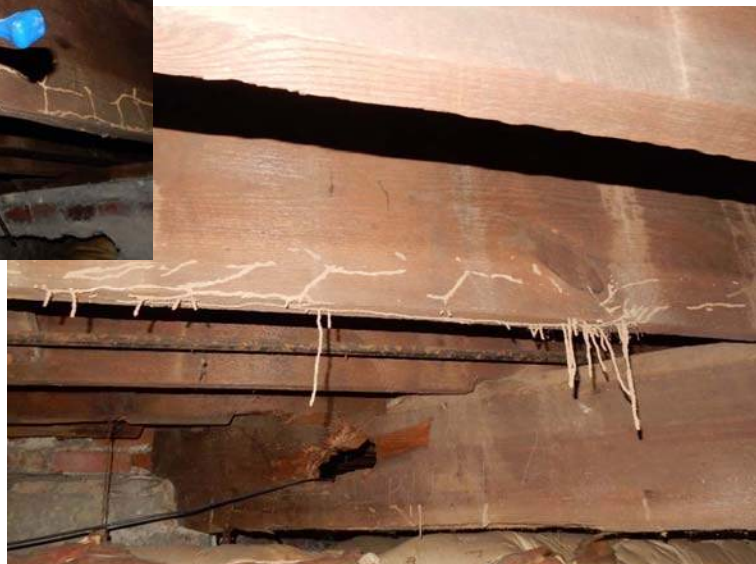
Hand tools,  
scratch awls.

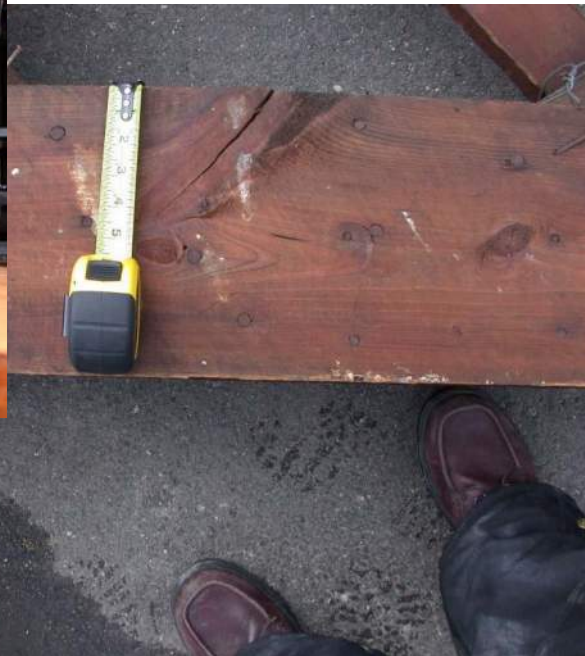
Levels and  
measuring devices.

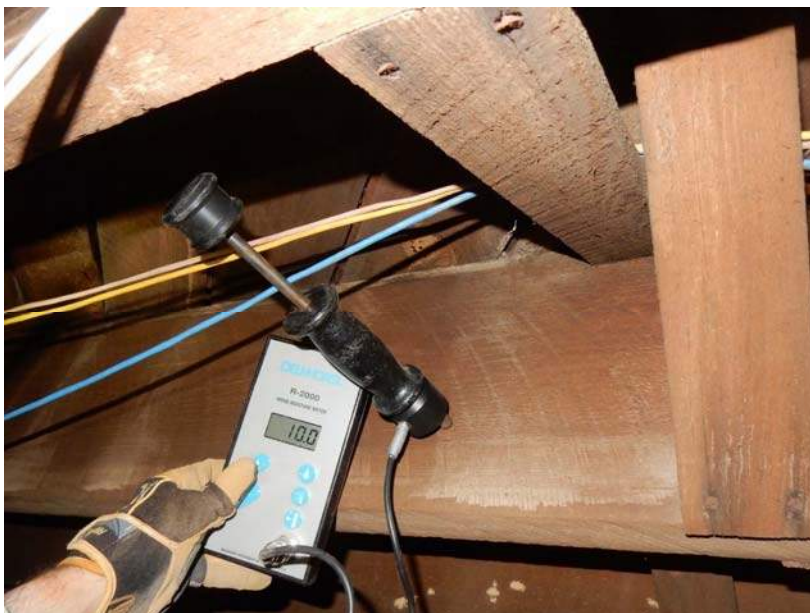
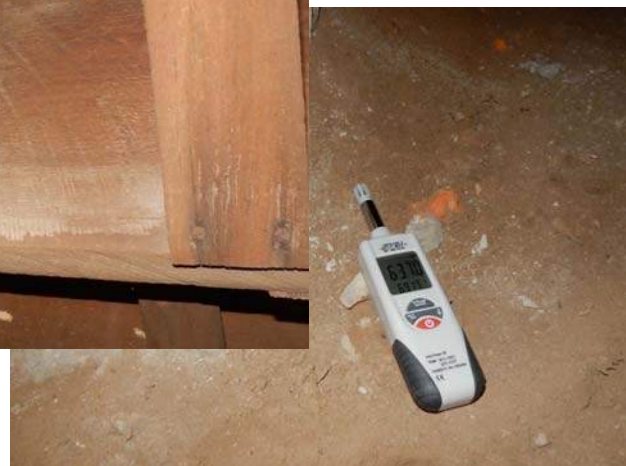
Moisture meters  
and hygrometers

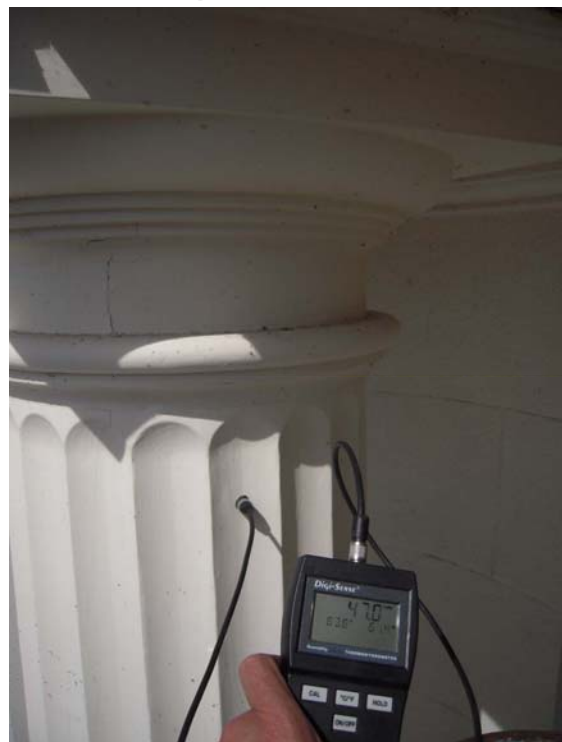
Wood plugs to  
assess glued joints  
and hygrometers with  
wands for cavities.

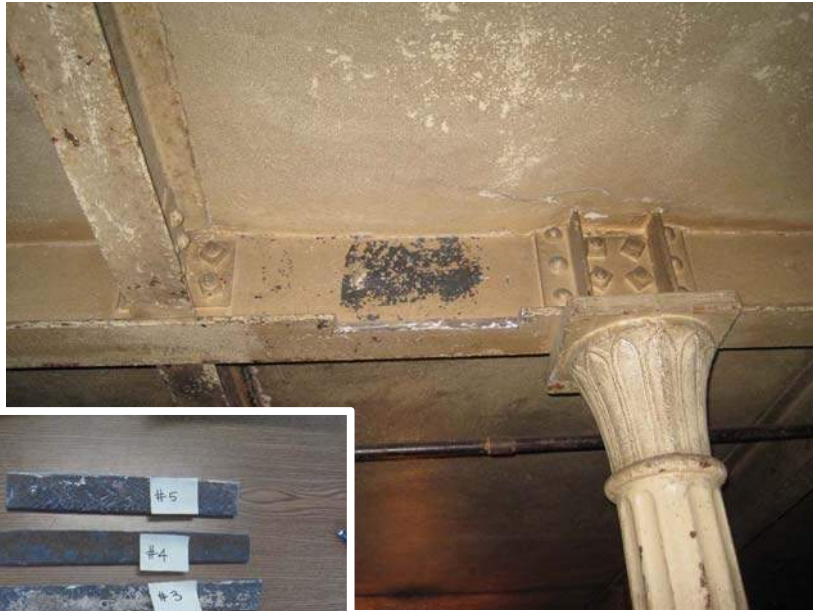
Steel coupons for yield and tensile strength tests and chemical analysis for determining weldability.

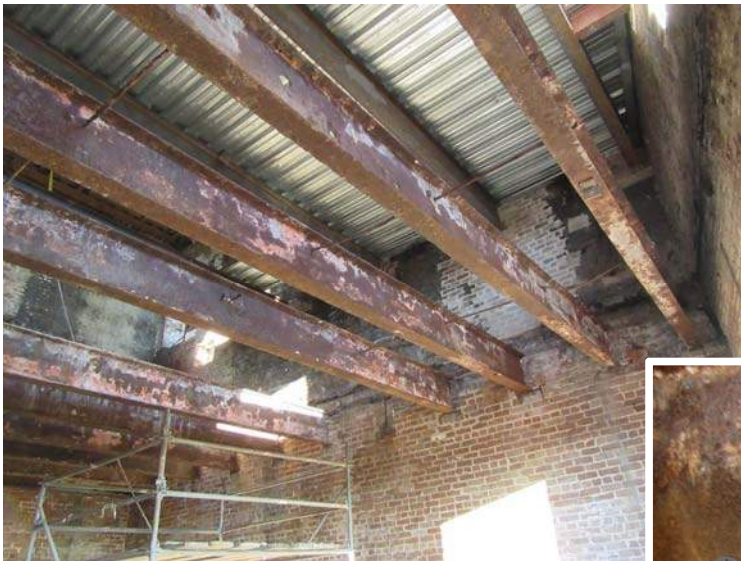
Ultrasonic thickness measuring device (Krautkramer) for blind measurements of steel members.

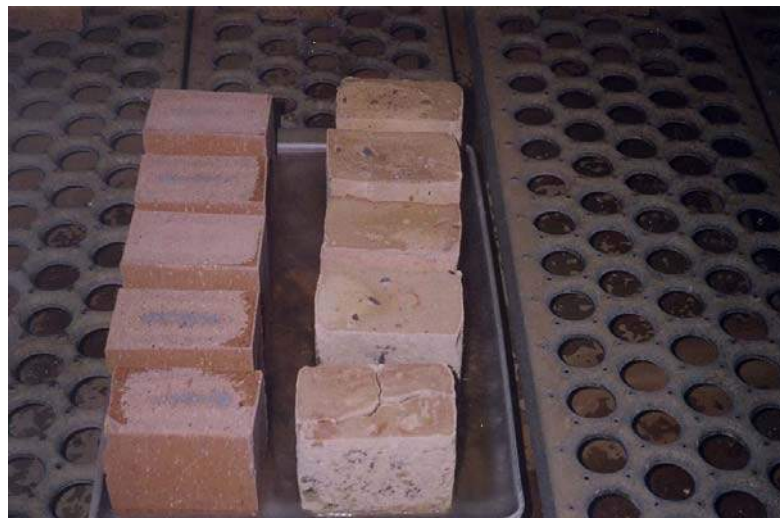
ASTM C67 - Compressive strength testing and freeze-thaw testing of proposed replacement material

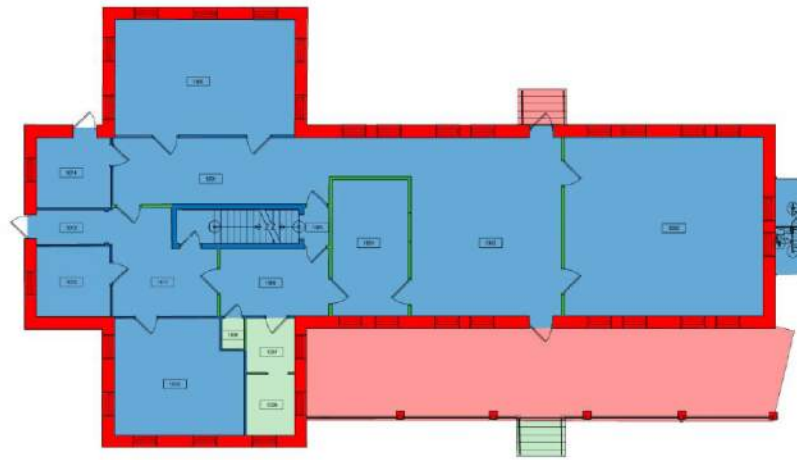
Figure 107. First floor plan showing preservation zoning. The building exterior is designated as Zone 1, including exterior stairs. The non-original stairs from the south porch are designated as Zone 3. The fire escape on the east elevation is designated as Zone 2. Most of the interior is designated as Zone 2, except for bathrooms, which are designated as Zone 3. Non-original partition walls are also designated as Zone 3.

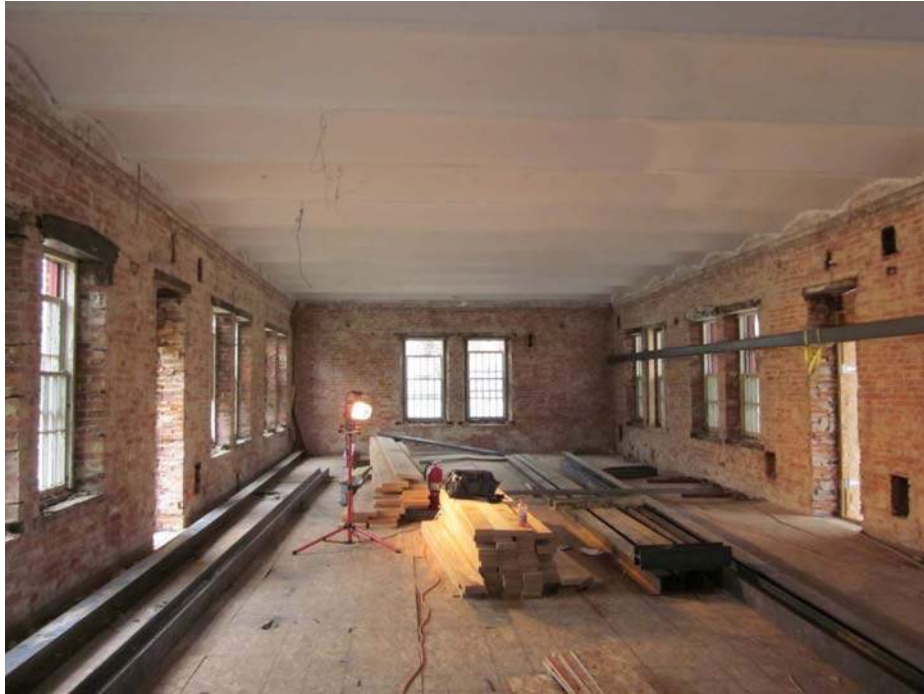
## Wall bracing

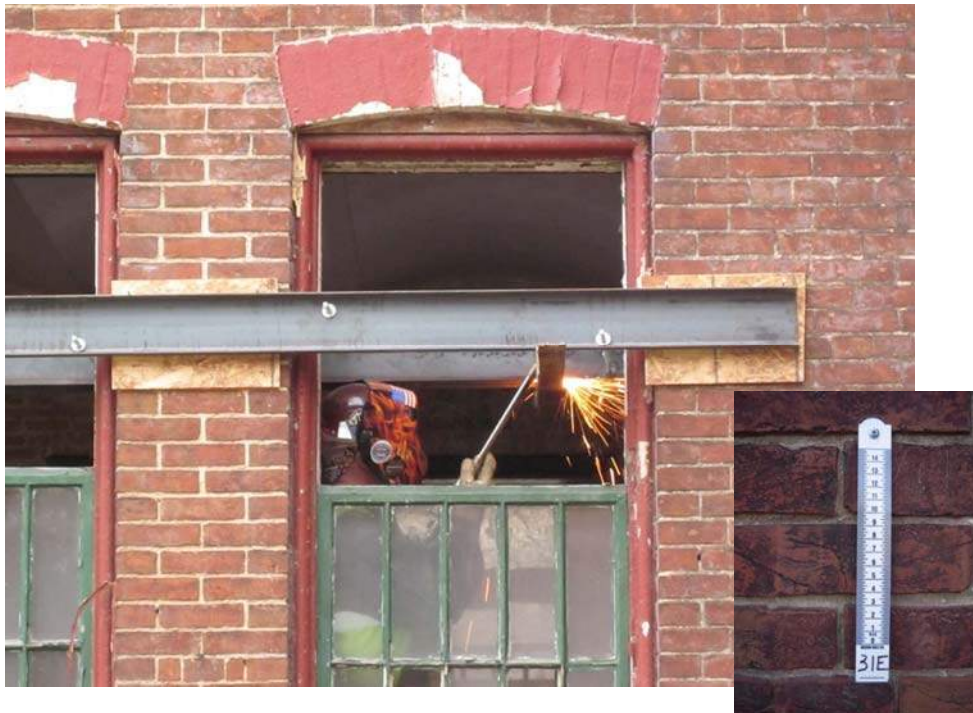
## Wall bracing / monitoring

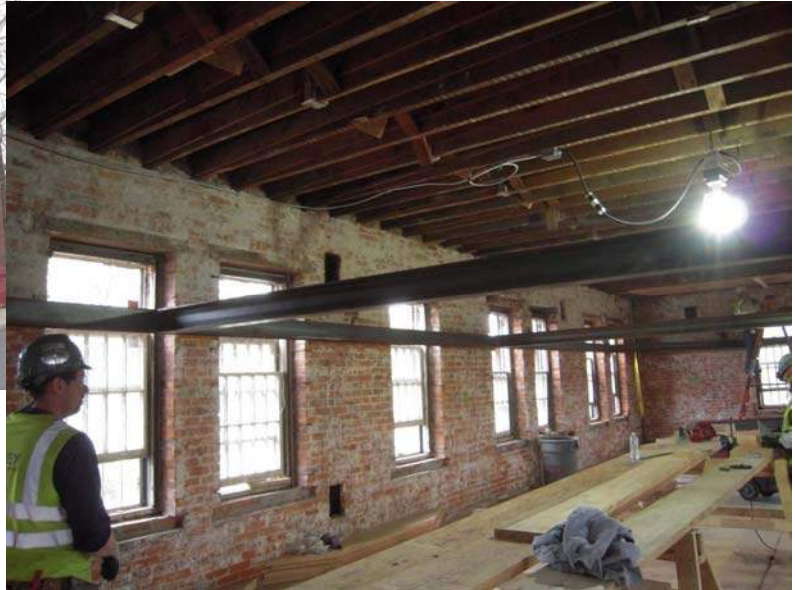
## Wall bracing

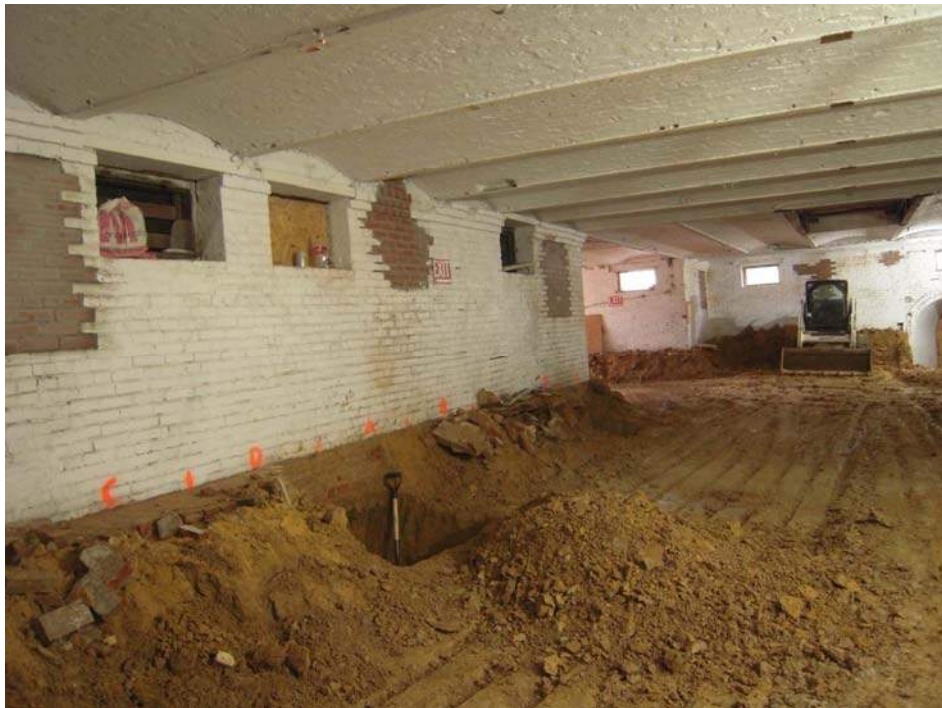
## Underpinning work commenced

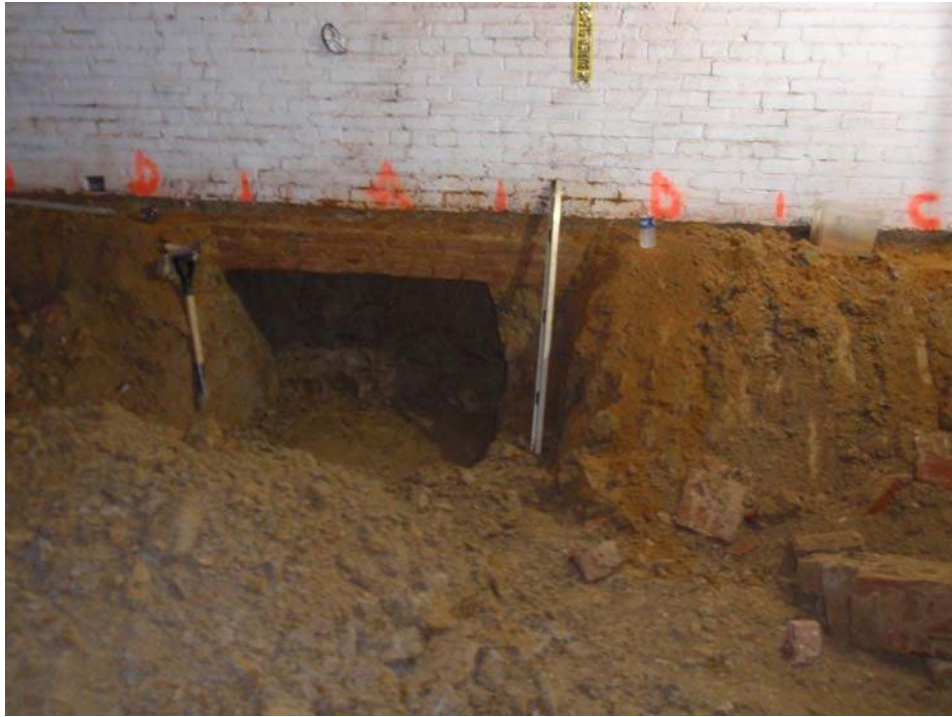
## Underpinning work in progress

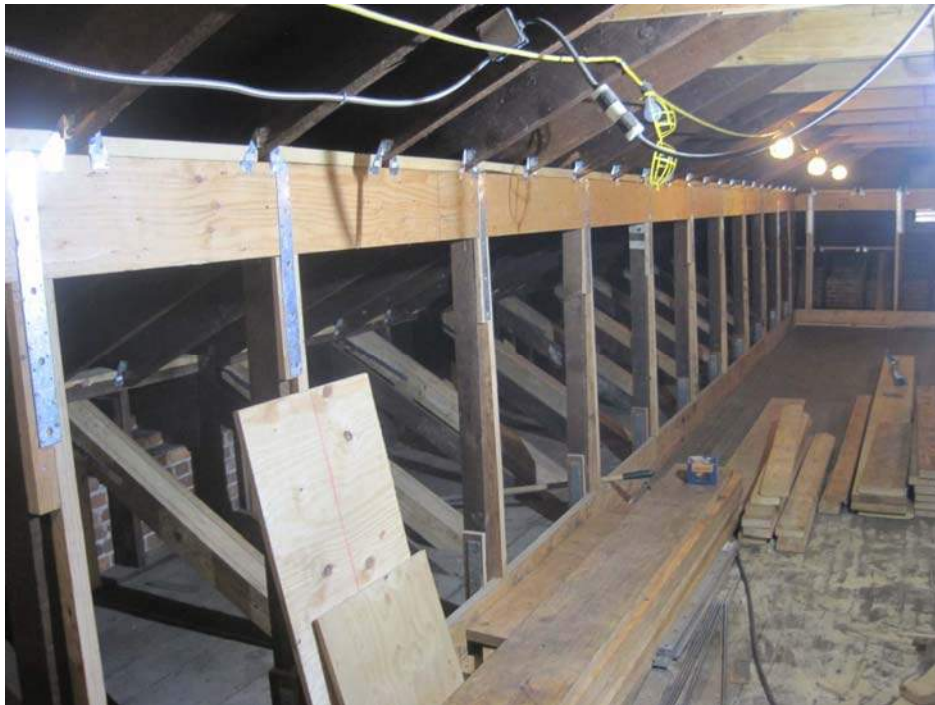
## Roof framing reinforced

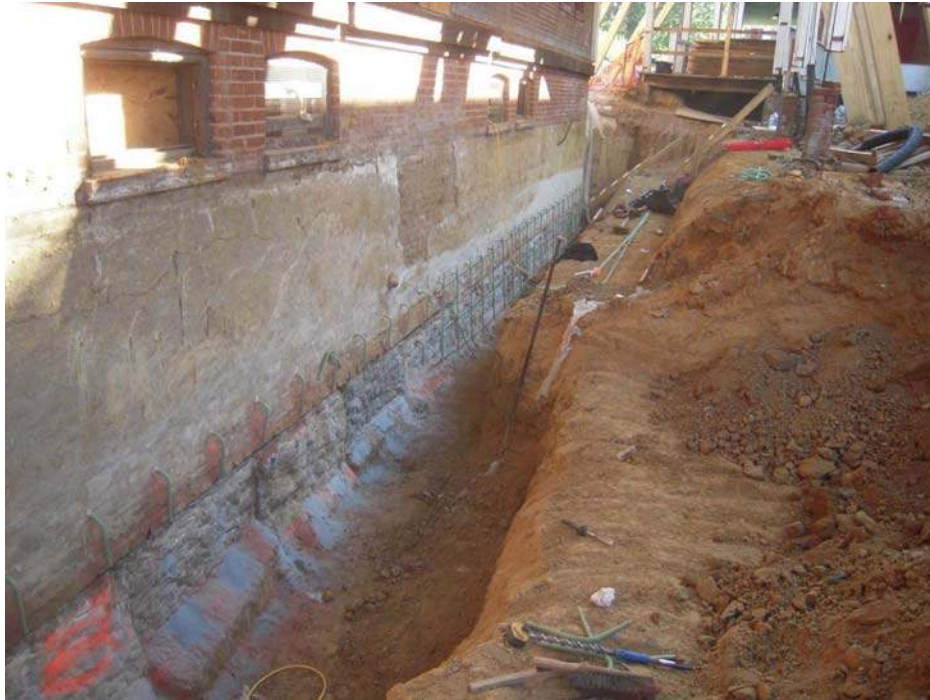
## Concrete Jacket

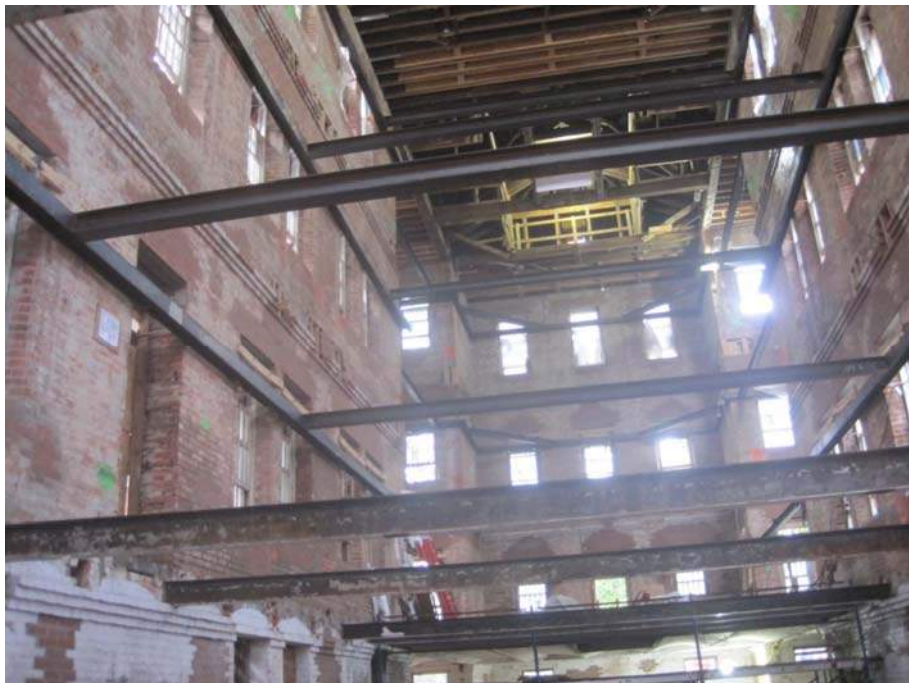
## The last steel beams were removed

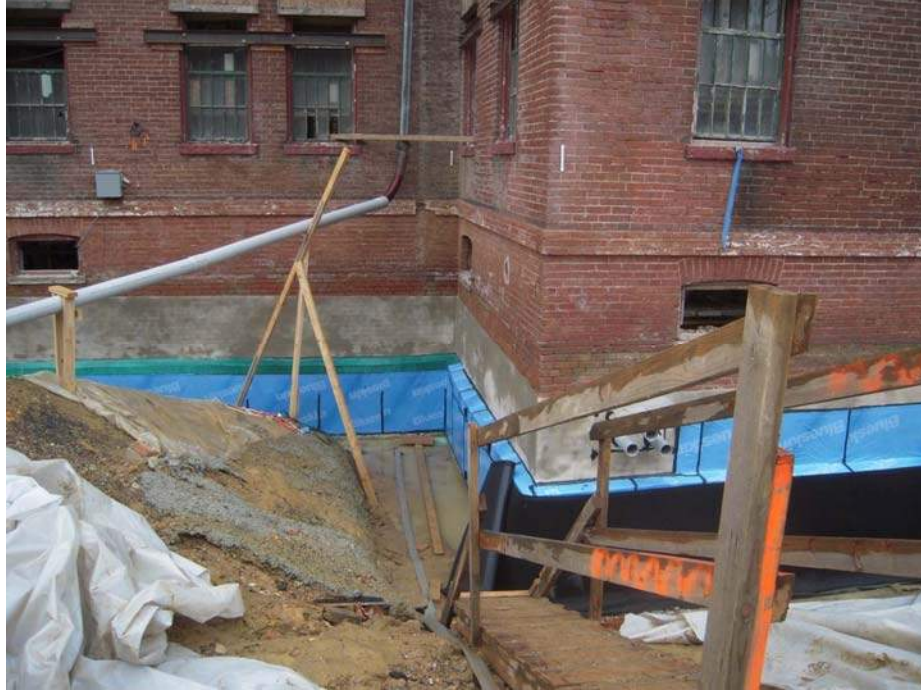
## Waterproofing and drain tile

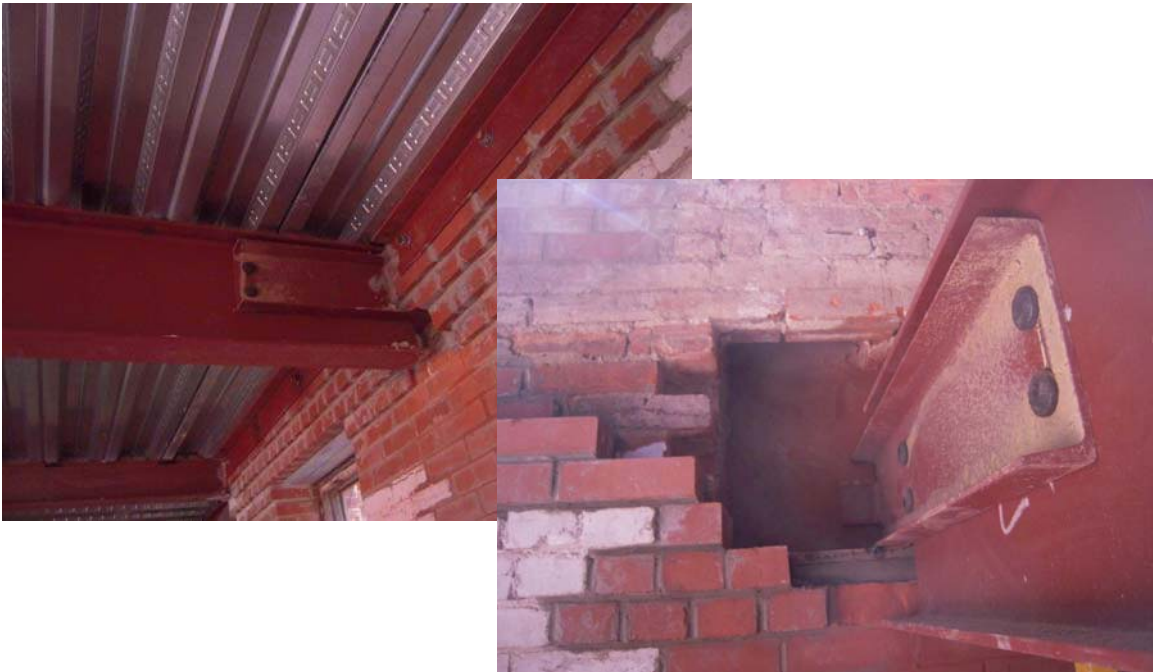
## Steel framing installation

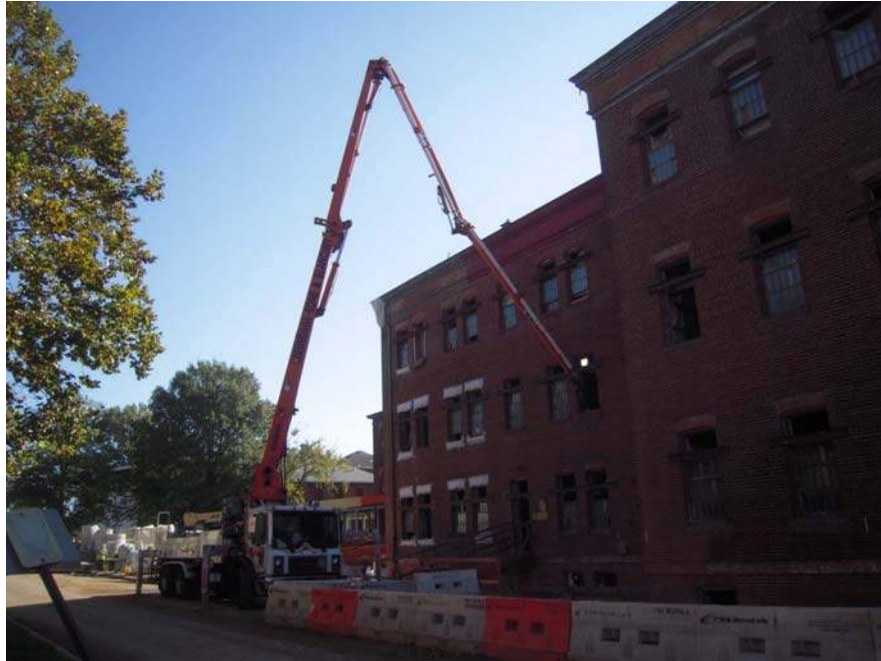
# Concrete Placement

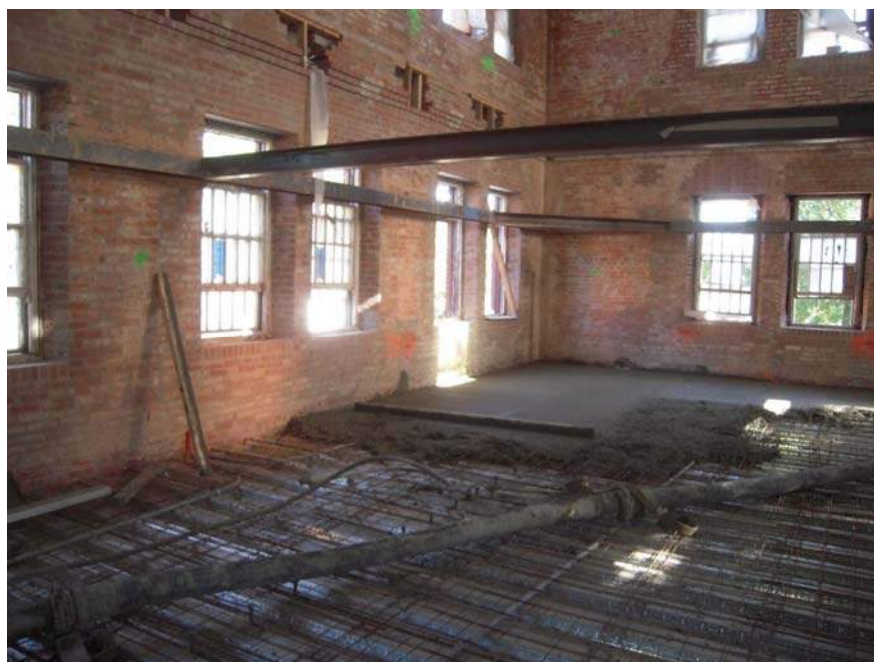
# Concrete Placement

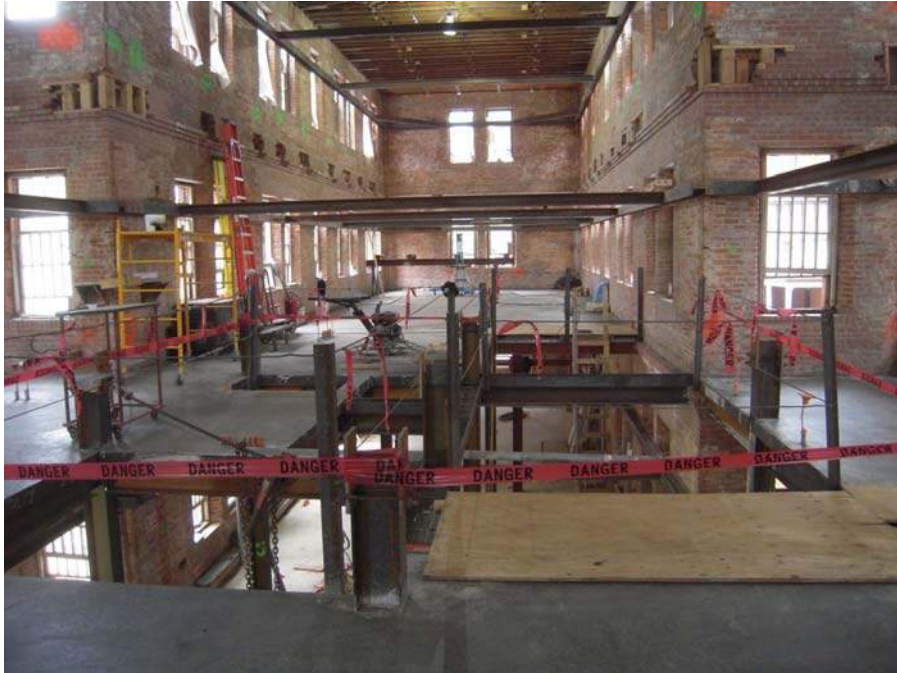
## Steel framing installation

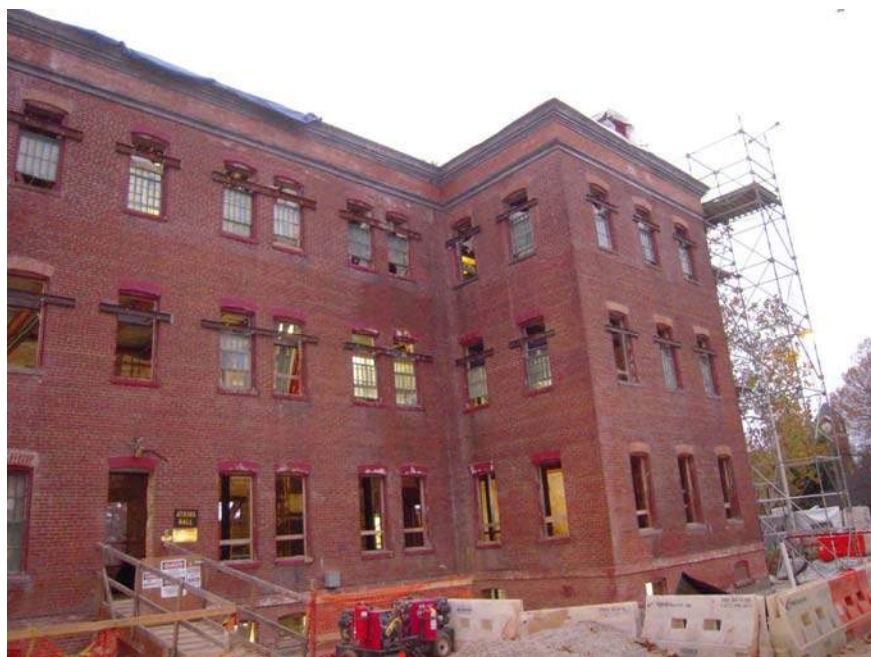
## Lateral Bracing Removal

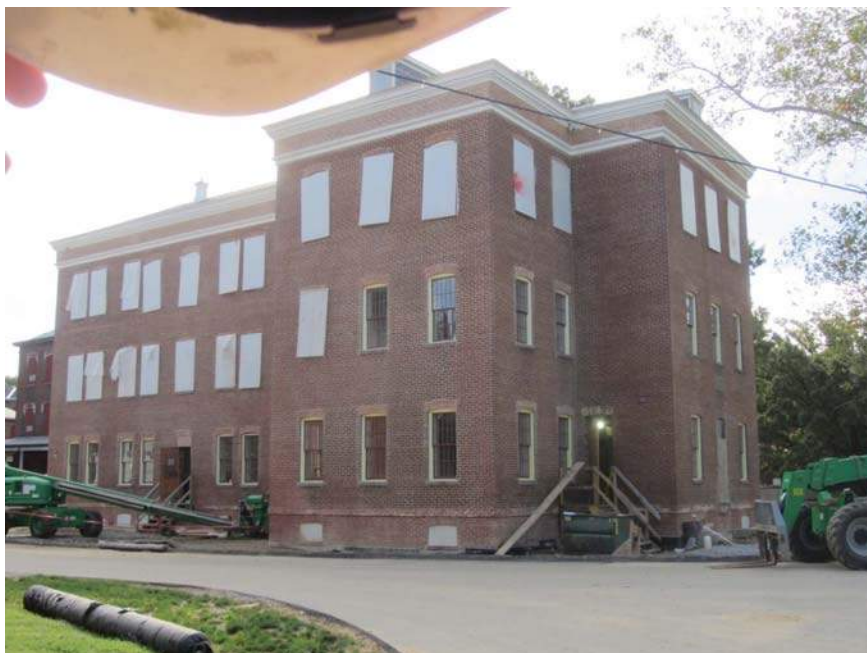
## Window installation in progress
